Proposed Mixed Use Development Lindfield Community Hub Project

Report on
Geotechnical Investigation

3914-R1-Rev2
12 December 2016

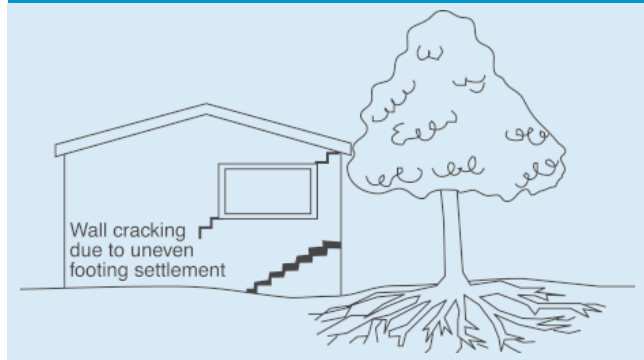
Trees can cause shrinkage and damage

As the weather pattern changes and the soil begins to dry out, the external footings will be first affected, beginning with the locations where the sun's effect is strongest. This has the effect of lowering the external footings. The doming is accentuated and cracking reduces or disappears where it occurred because of dishing, but other cracks open up. The roof lines may become convex.

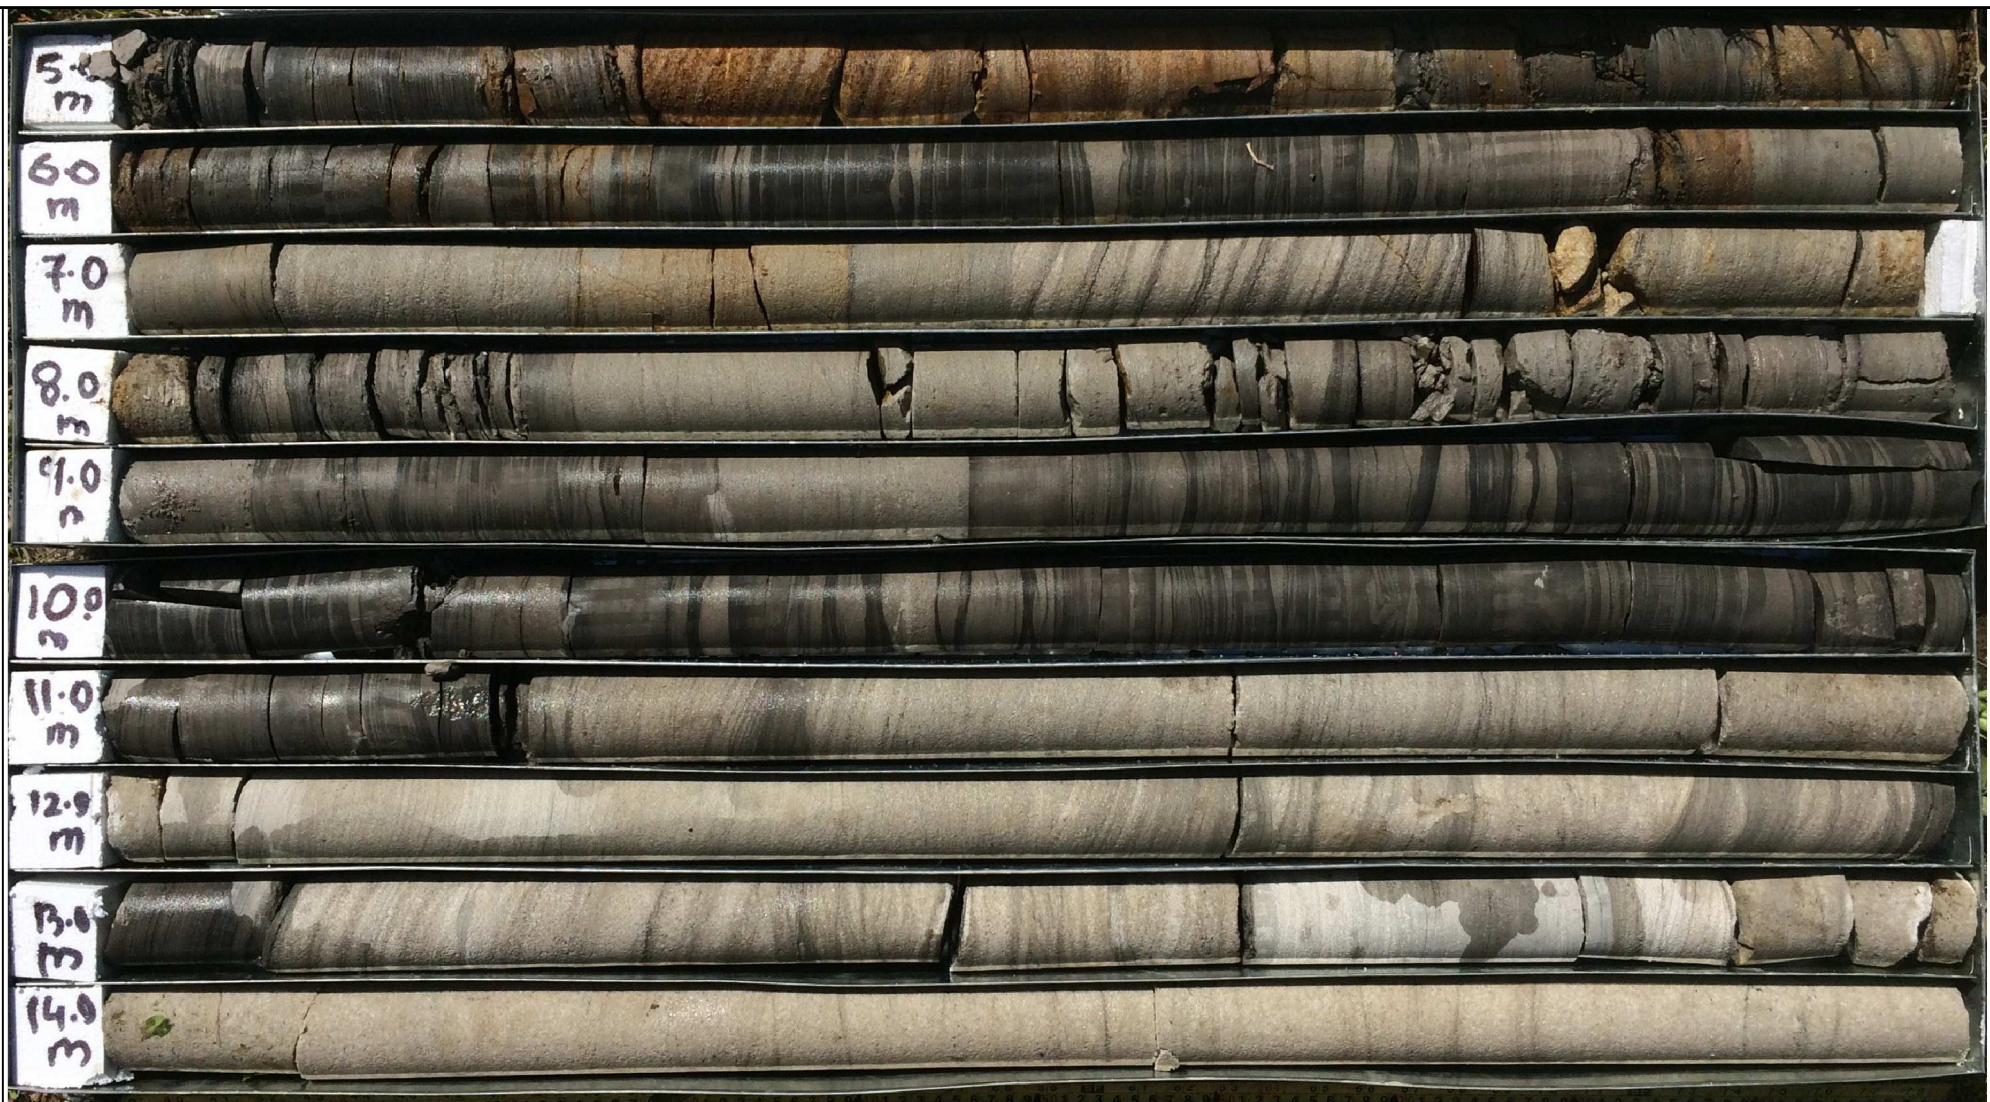
Cored Borehole Log

client: Ku-ring-gai Council		started: 21.9.2016	
principal:		finished: 22.9.2016	
project: Lindfield Community Hub		logged: DJ	
location:		checked: MAG	
equipment: Edson 100 Truck mounted		RL surface: 88 m	
diameter: 125mm		datum: AHD	
inclination: -90°		bearing: --- E: N:	
drilling information		material information	
method	support & core-lift	water	RL
depth metres	graphic log	core recovery	rock substance description
weathering	estimated strength	Is MPa	defect spacing mm
EL 0.03	VL 0.1	UL 0.3	HT 1
VT 3	VT 10	ET	RD %
DL = diametral	AL = axial	1.32	20
60	200	600	2000
defect description	specific	general	
NMLC		SANDSTONE, fine to medium grained, grey, poorly developed bedding planes. (continued)	
73.0		15.0	
72.5		15.5	
72.0		16.0	
71.5		16.5	
71.0		17.0	
70.5		17.5	
70.0		18.0	
69.5		18.5	
69.0		19.0	
68.5		19.5	
		BH1 terminated at 15m

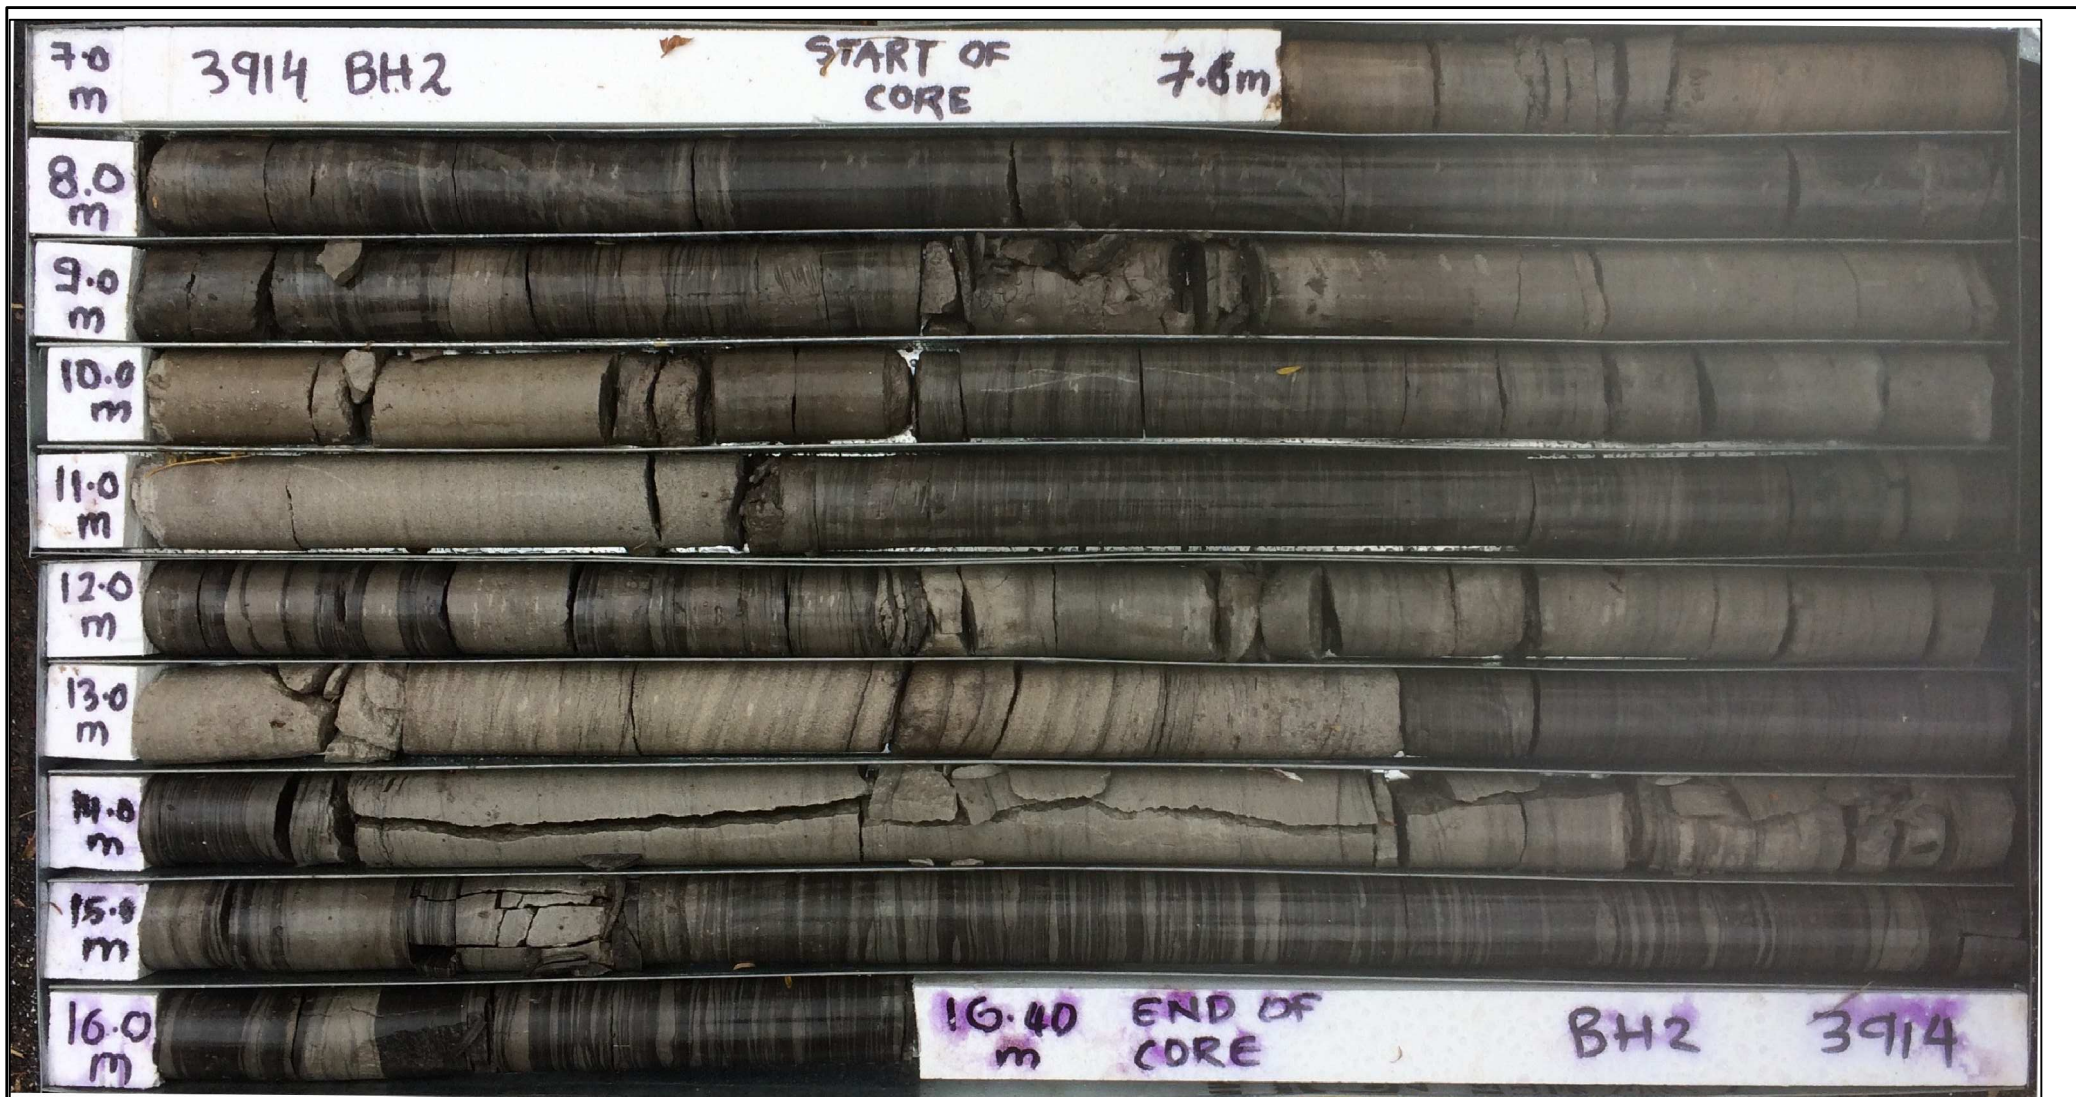
ASSET GEOTECHNICAL geotechnical engineering consultants info@assetgeotechnical.com.au			PROPOSED MIXED-USE DEVELOPMENT 2 BENT ST, LINDFIELD, NSW for KU-RING-GAI COUNCIL			drawn: TT date: 28.09.16 checked: MAG scale: NTS			job no.: 3914 fig: BH2 issue: A											
SYDNEY 2.05/56 Delhi Rd North Ryde NSW 2113 Ph: 02 9878 6005			CORE PHOTOS

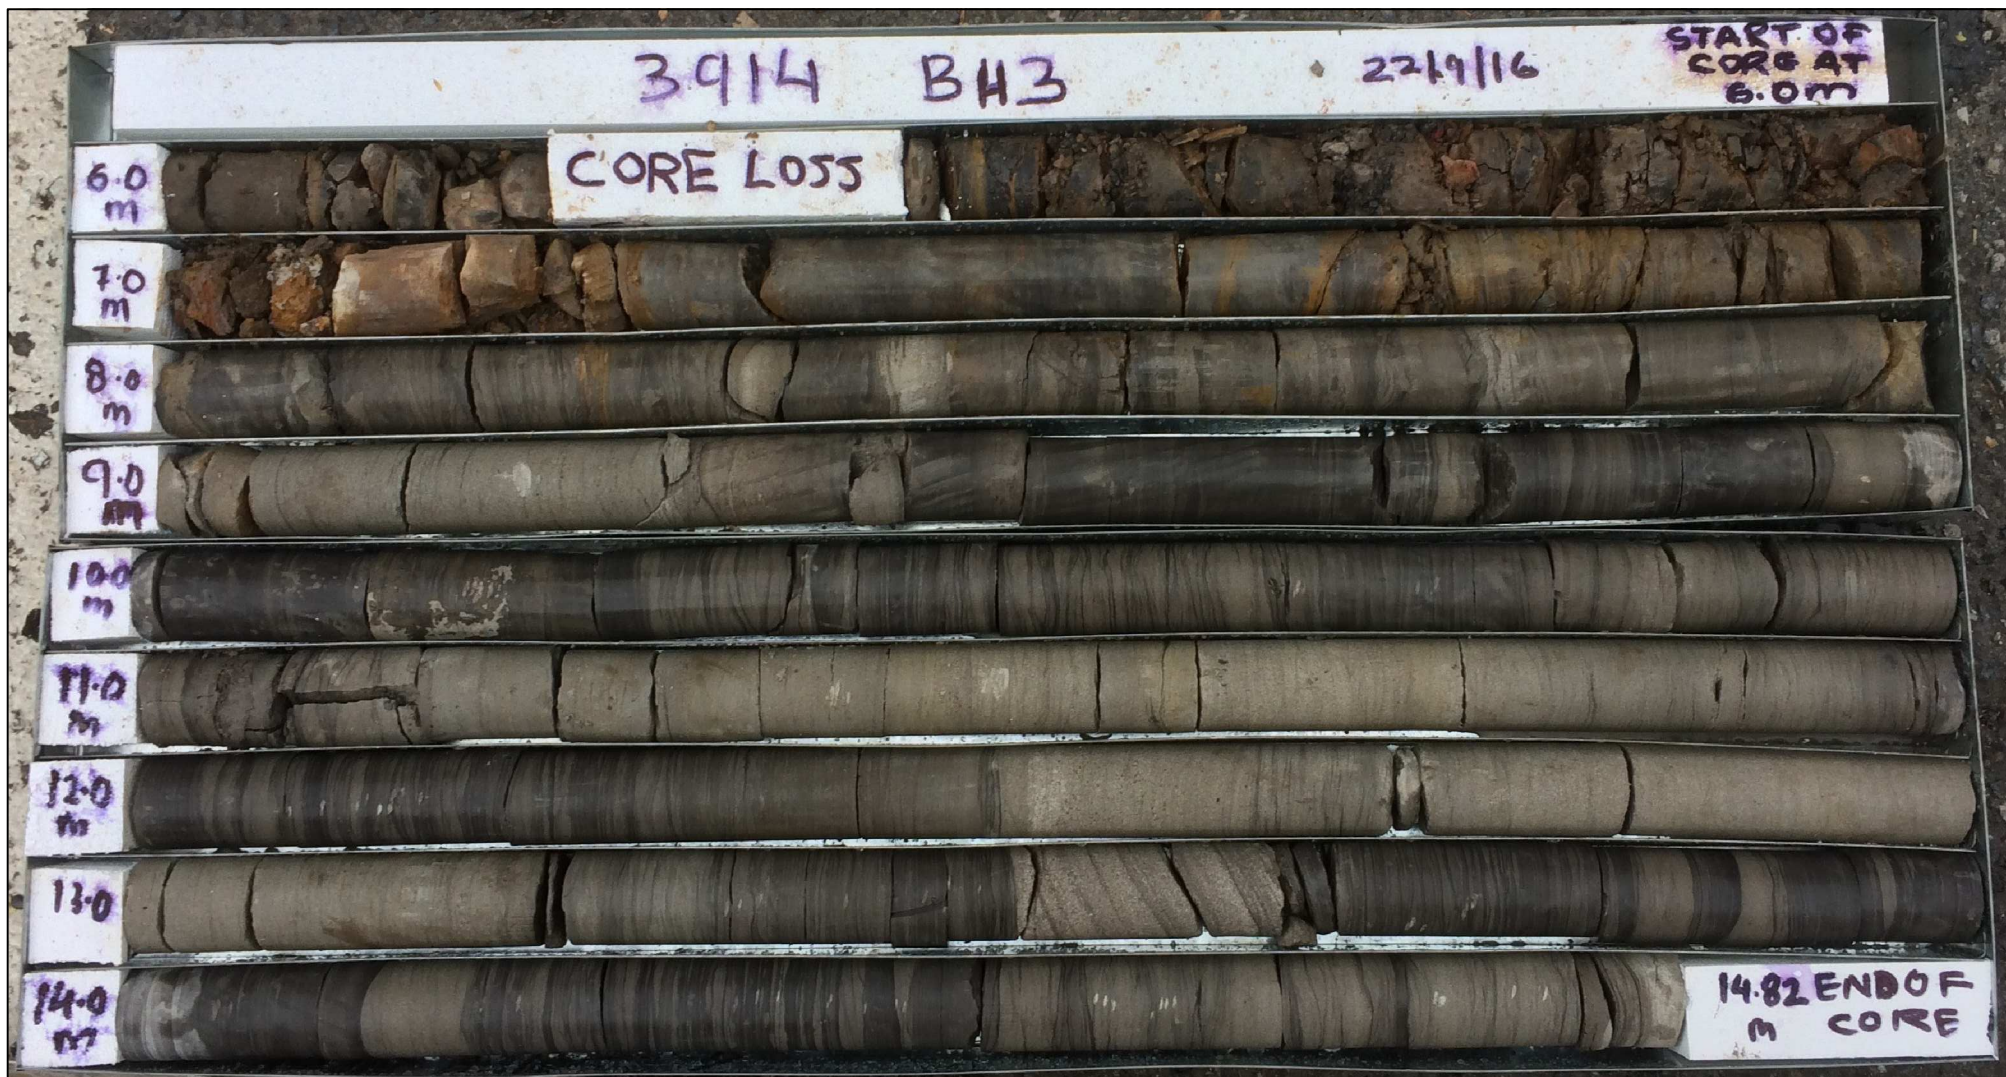
client:		Ku-ring-gai Council				started:		22.9.2016						
principal:						finished:		22.9.2016						
project:		Lindfield Community Hub				logged:		DJ						
location:						checked:		MAG						
equipment:		Edson100 Truck mounted				RL surface:		95 m						
diameter:		125mm		inclination: -90° bearing: --- E: N:		datum:		AHD						
drilling information					material information					rock mass defects				
method	support & core-lift	water	RL	depth metres	graphic log core recovery	rock substance description rock type; grain characteristics, colour, structure, minor components	weathering	estimated strength MPa	Is MPa ₍₅₀₎ D= diametral A= axial	defect spacing mm	defect description			
											type, inclination, thickness, shape, roughness, coating			
											specific	general		
NMLC						Interbedded LAMINITE and SILTSTONE, poorly developed layering, dark grey, bedding planes at 0-5° (continued)	HW - MW					PT 0-5° pl sm cl

JT 0-5° pl ro cl		
												0-10° un ro cl		
												PT 0-5° pl ro cl		
												JT 0-5° pl ro/sm cl		
												vertical joint		
												CZ 50mm		
												vertical joint		
						SANDSTONE, grey, fine to medium grained	MW - SW					JT 0-5° pl sm cl		
												PT 0-5° pl sm cl		
												JT 0-5° pl sm cl		
												PT 0-5° pl sl sm		
												PT 0-5° pl sm cg		
												PT 0-5° pl sm cl
